Inspection Report

Minerals Regulatory Program

Mine Name: Reef
Operator Name: Castle Valley Stone

Permit number: S0150094
Inspection Date: April 21, 2008
Time: 5:00-5:15 PM

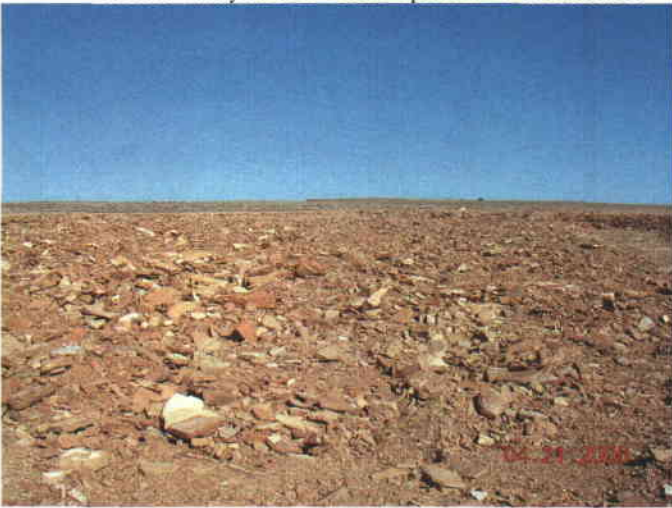
I was able to find a few snakeweed plants but that's all, not even weeds. I saw no seeded vegetation at all.

Photo 1. This is the waste rock. Note the lack of vegetation.

I recommend that the operator finish grading and re-seed the area this fall. If this happens, access should be blocked so it is less likely the site will be used by off road vehicle riders. I have heard that Southwest Stone may still want to mine this area, and the site should not be regraded and seeded if this is going to happen soon.

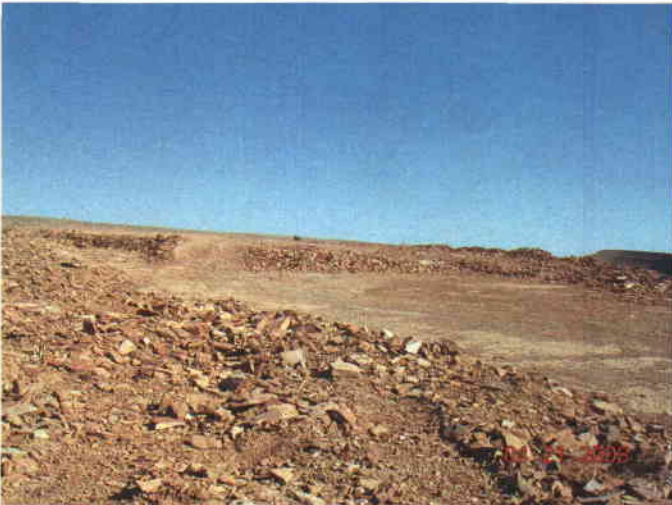
7. Backfilling/Grading (trenches, pits, roads, highwalls, shafts, drill holes)
The operator has done no additional grading work, but the pallets of rock have been removed.

Photo 2. This is part of what needs to be regraded.

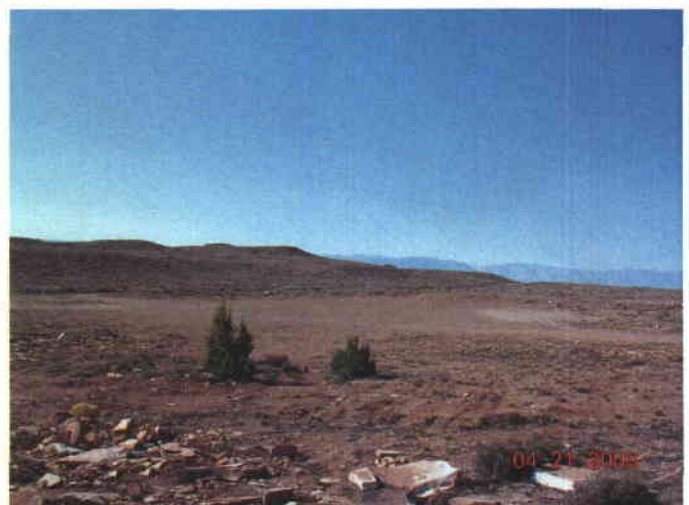
The area has evidence that people have been driving in some of the smoother places away from the waste rock.

Photo 4. This is where most of the product was being stored, and it is also the area from which off road vehicles access the site.
